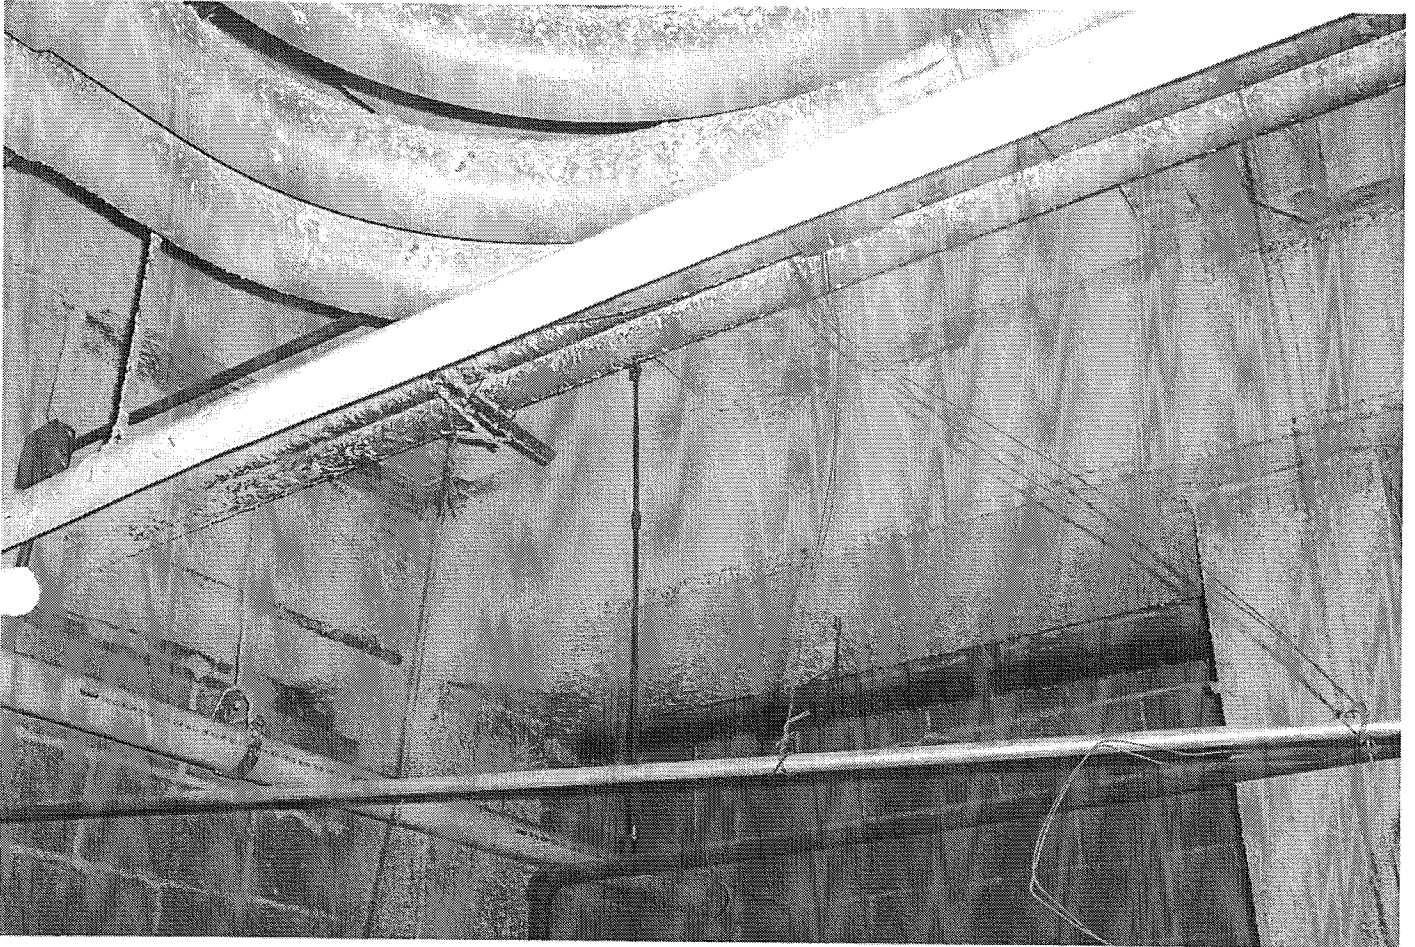
17. Main Terminal, Basement, South Hallway - General view of fireproofed concrete decking and structure above Ladies Rm

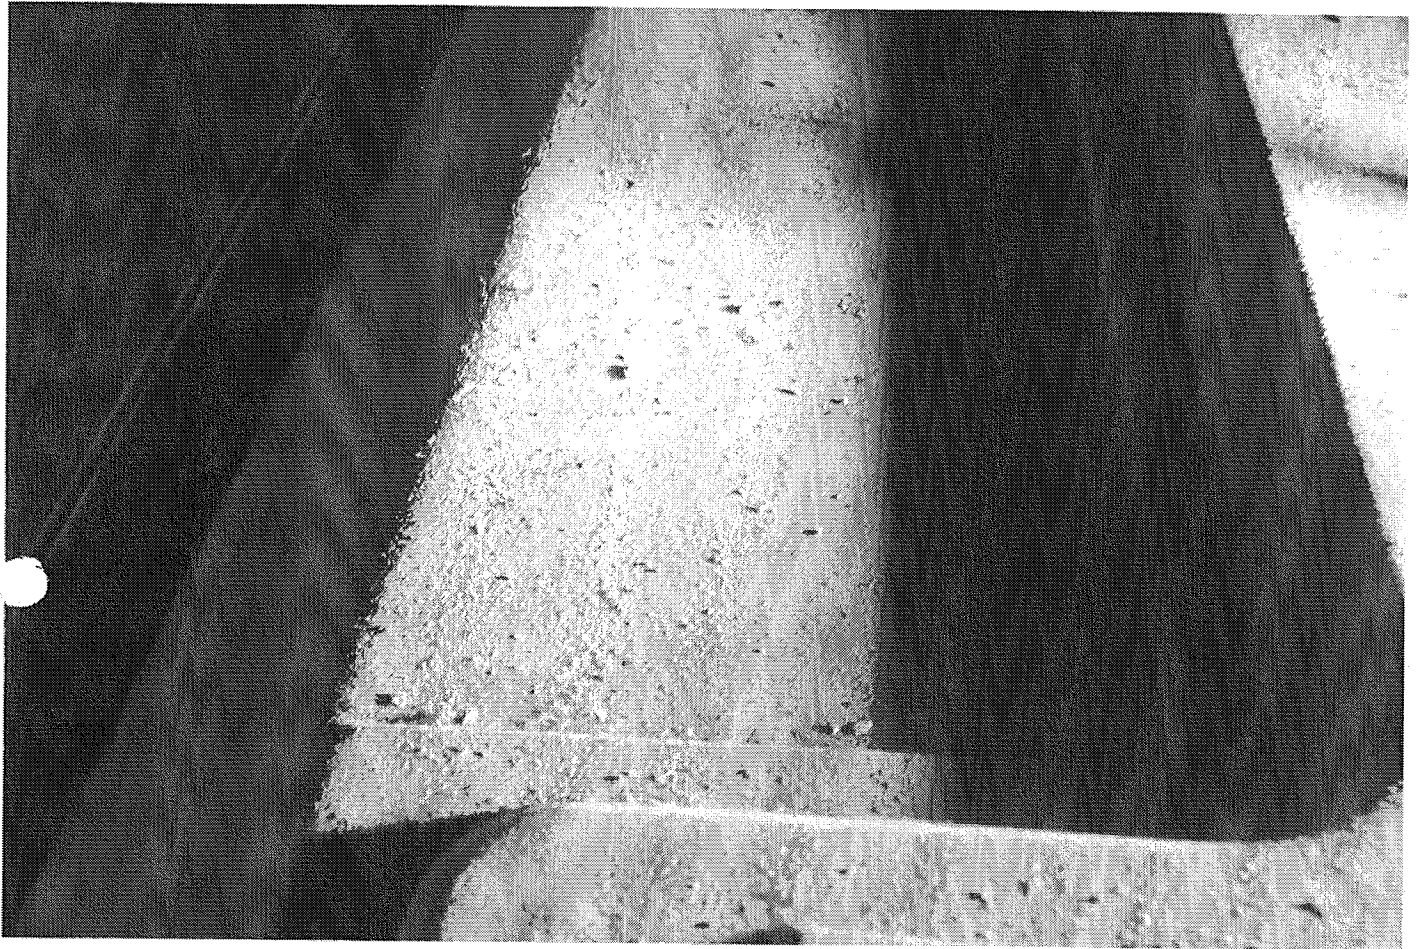
18. Main Terminal, Basement, South Hallway - View of delaminated fireproofing dust on top of fluorescent light fixture (location of dust sample #5)

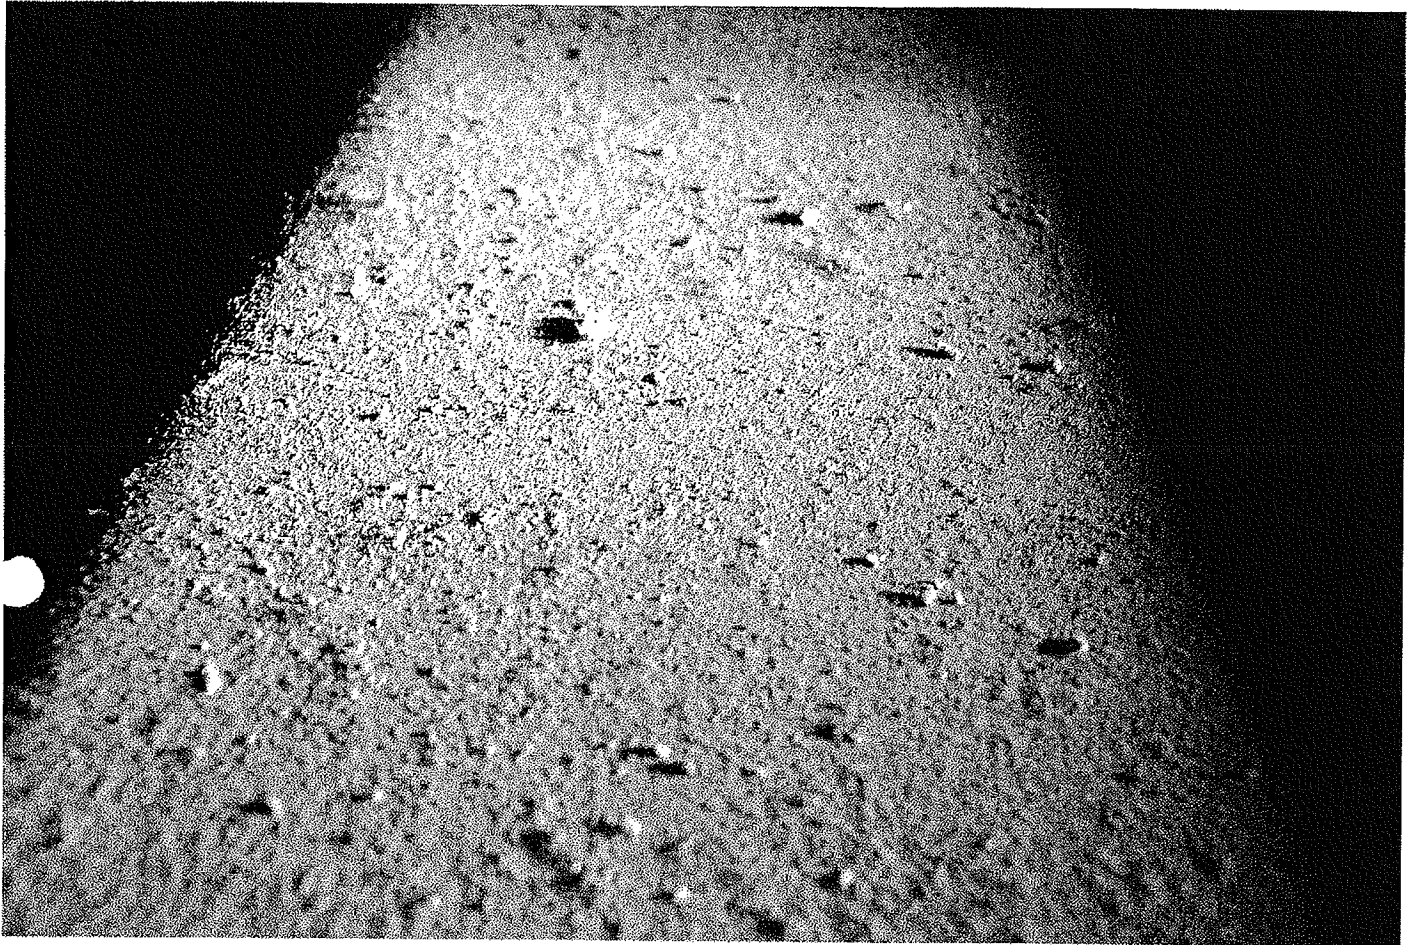
19. Main Terminal, Basement, South Hallway - Close-up of delaminated fireproofing dust on top of fluorescent light fixture

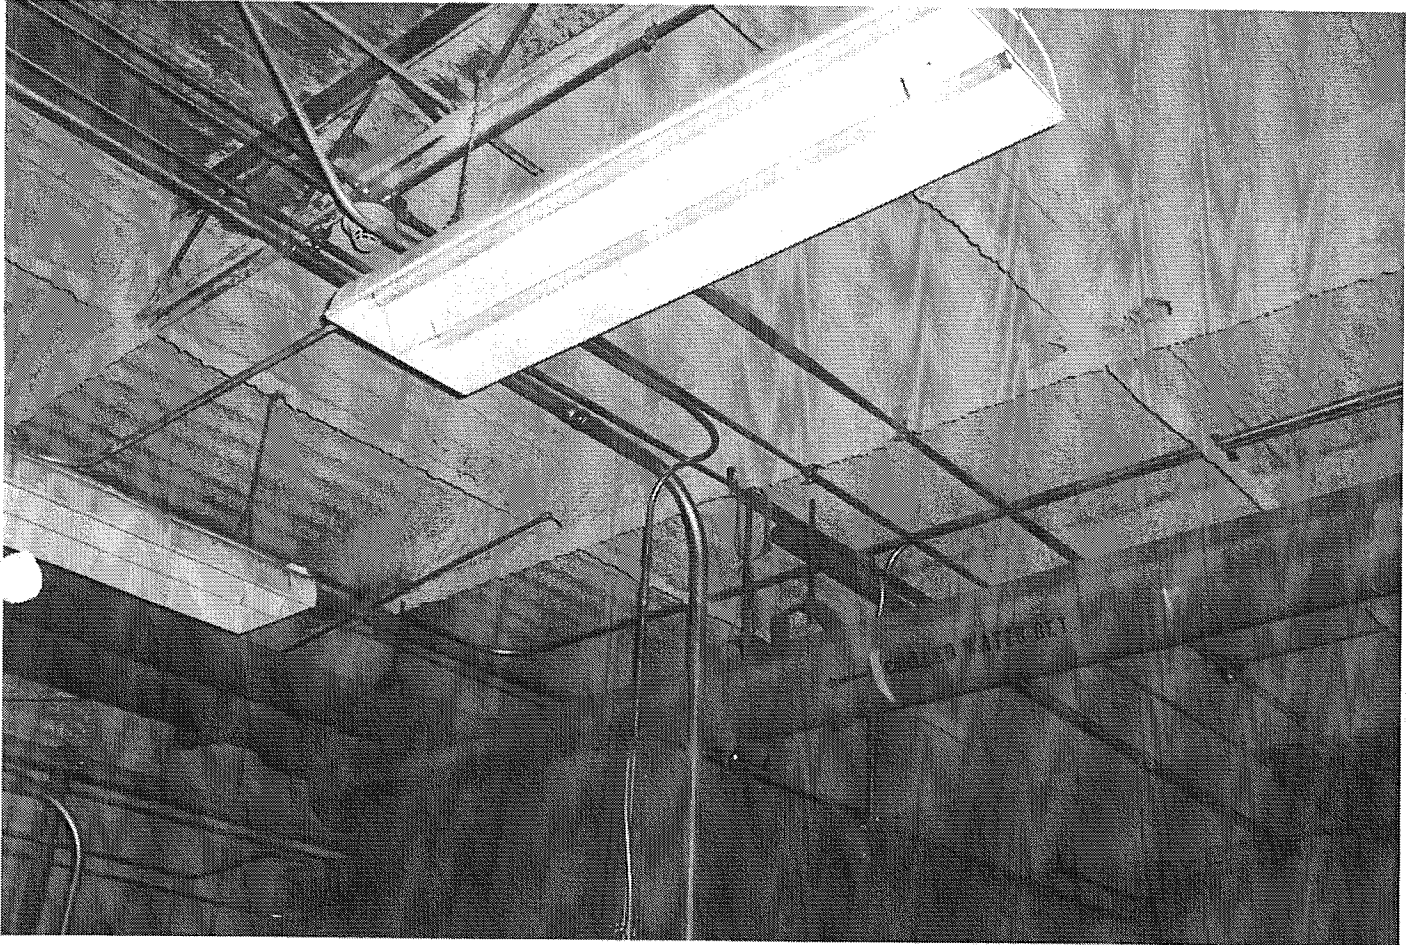
20. Main Terminal, 3rd floor, Air Handler Room - General view of exposed fireproofed metal decking and beams

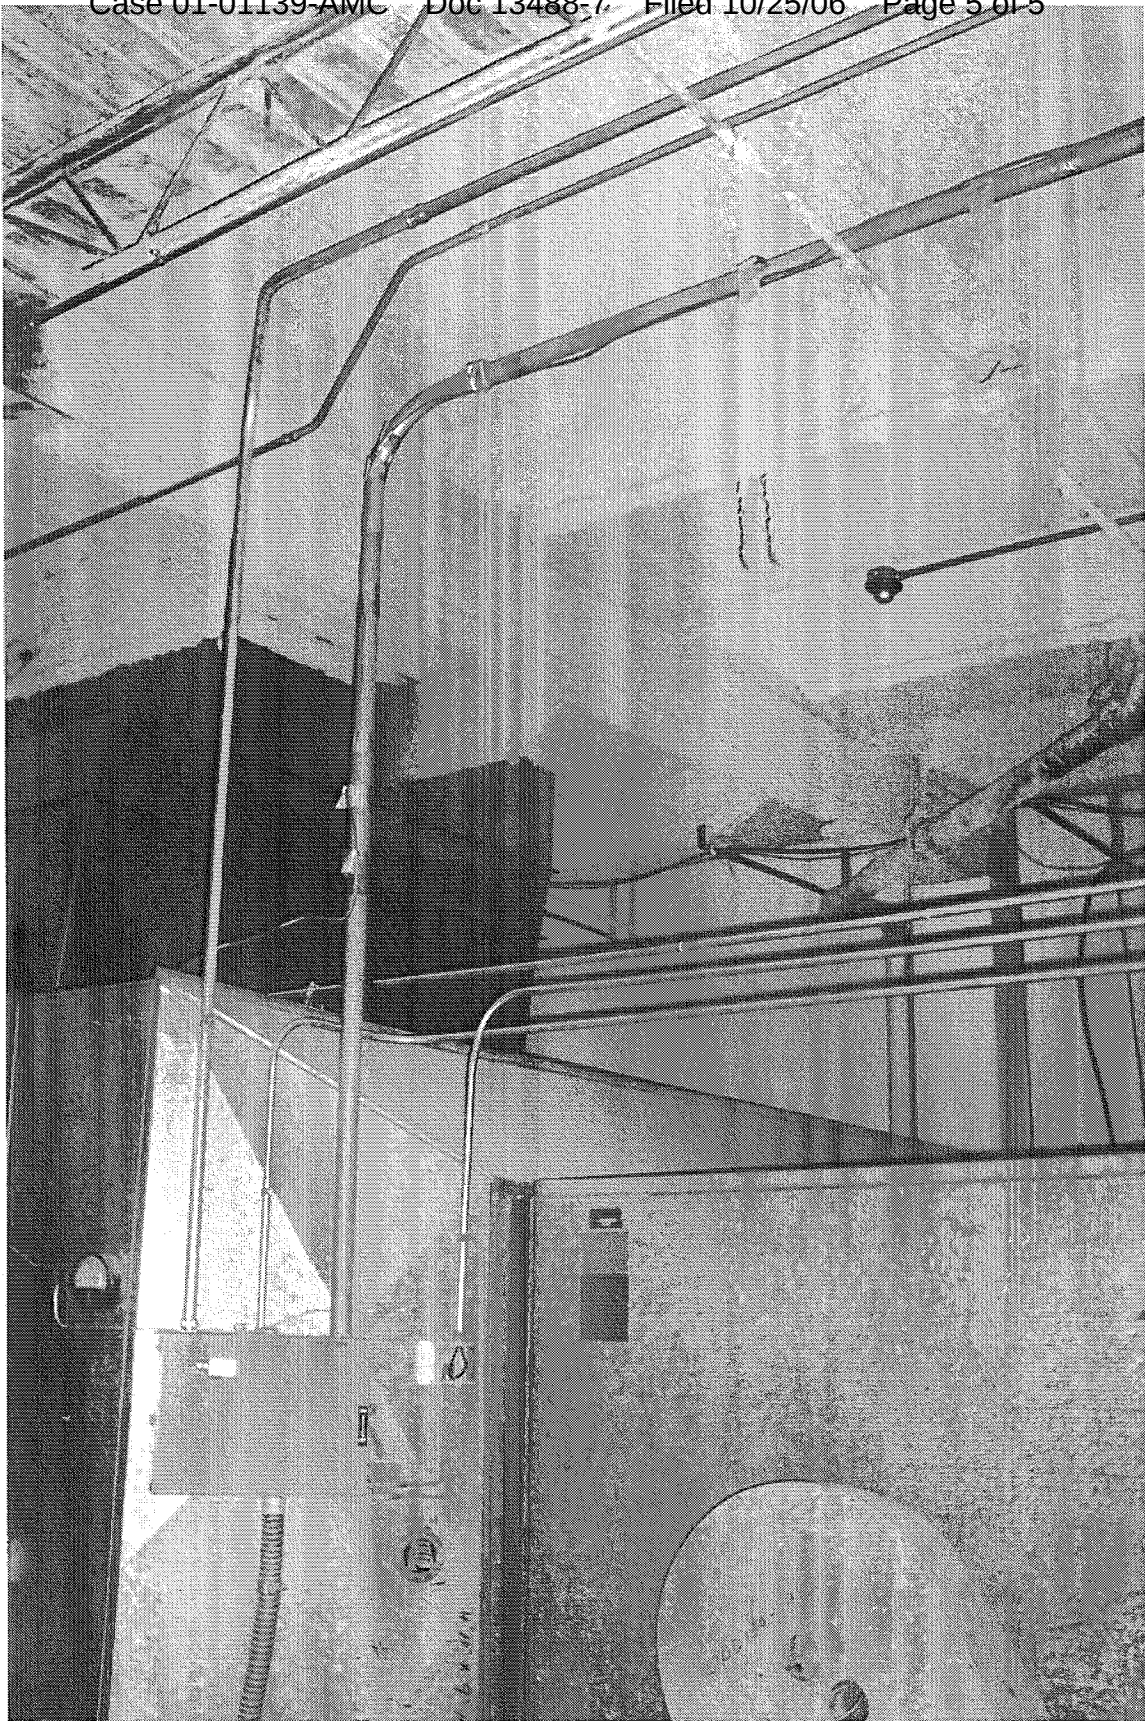
21. Main Terminal, 3rd floor, Air Handler Room - View of exposed fireproofed decking and beams above HVAC fan unit
